FINAL REPORT • FEBRUARY 2025

## Pico Creek Instream Flow Study

San Simeon Community Services District  
111 Pico Avenue  
San Simeon, CA 93452

Stillwater Sciences  
895 Napa Avenue, Suite B-3  
Morro Bay, CA 93442

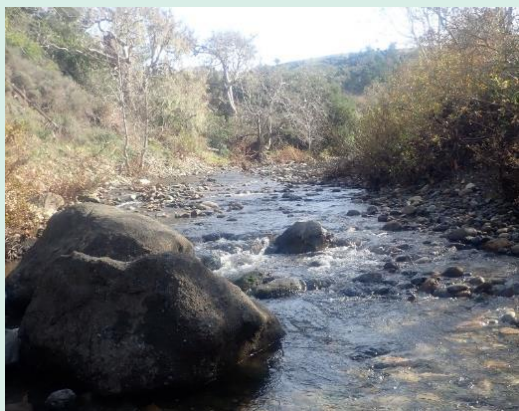
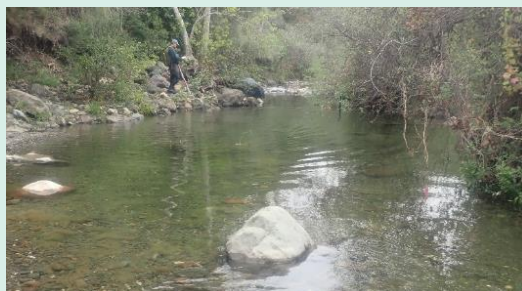
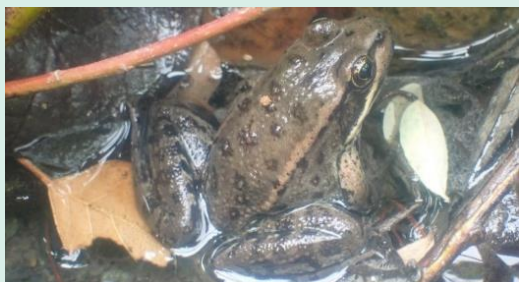
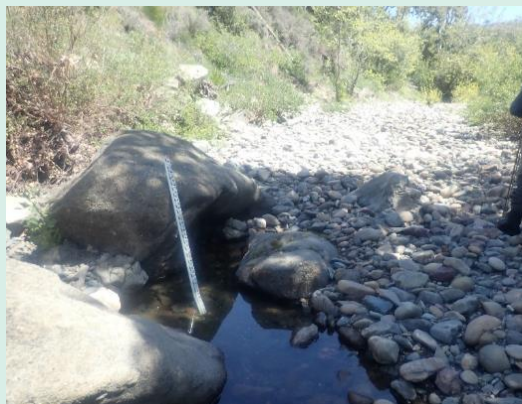
Cover photo: Riffle habitat in Pico Creek at approximately 4 cfs in January 2022 (top left), pool with stage level monitoring equipment (top right), California red-legged frog observed in Pico Creek (bottom left), and riffle habitat in Pico Creek dry in April 2022 (bottom right).

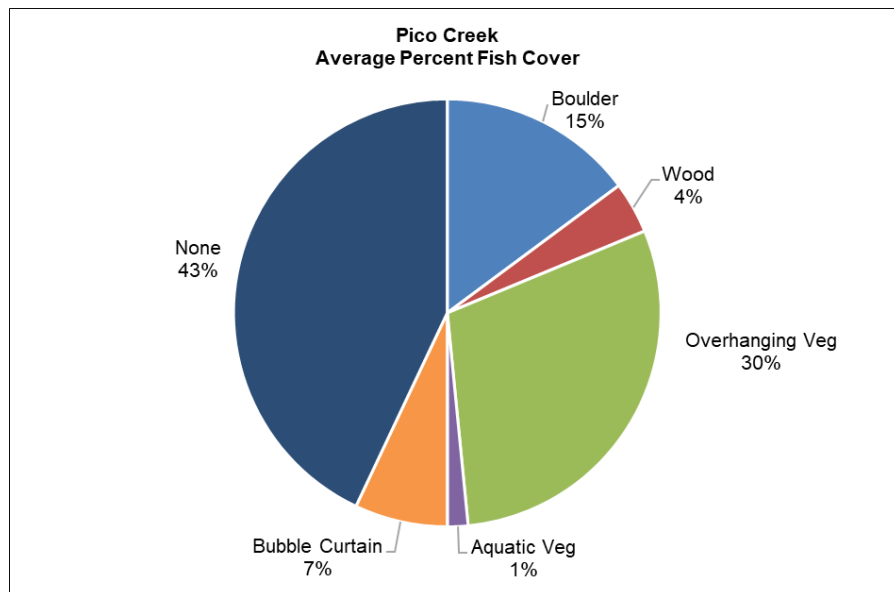
Figure 9. Average percent of fish cover within the Study Area.

Stream habitat typing was conducted throughout the Study Reach on January 14, 2022, beginning at the upstream end of the lagoon and extending approximately 0.83 miles upstream. The Study Reach is dominated by pool habitat (both mid-channel and lateral scour pools were observed), followed by riffle habitat and run habitat (Figure 7). Substrate within pool habitat was predominantly sand while the riffle and run habitats were dominated by cobble and gravel substrates, respectively (Figure 8). The majority of the channel (43%) contained no cover for fish. The dominant cover type was overhanging vegetation followed by boulder (Figure 9).

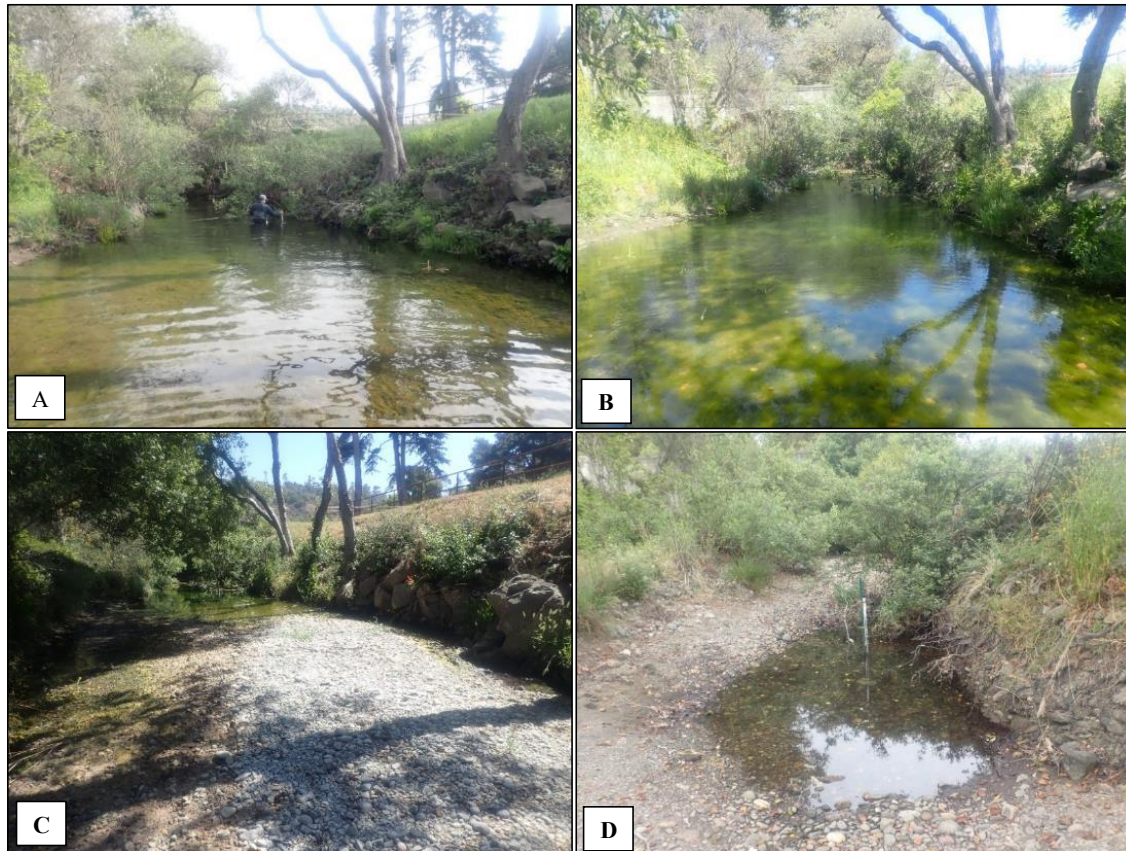
Figure 11. Looking upstream at pool where PT1 was installed on: (A) March 30 (0.86 cfs), (B) May 9 (0.05 cfs), (C) June 13 (0.0 cfs), and (D) July 12, 2022 (0.0 cfs).

Pressure transducers were installed in Pico Creek on March 15, 2022, when stream flow was 0.35 cfs. Water levels in pools were generally stable until surface flows became disconnected, at which point pool depths began to decrease quickly. Pool depths showed a quick response to rain events that occurred in late March and in late April. The April rain event occurred after stream flows had become disconnected in the upper section of the Study Reach, when water depths at the pools where PT2 and PT3 were located began to drop. Following the April rain event, water levels in these locations briefly rose by approximately 0.5 ft but then began dropping almost immediately (Figure 10). Photos of each pool where pressure transducers were installed are shown in Figures 11–13.

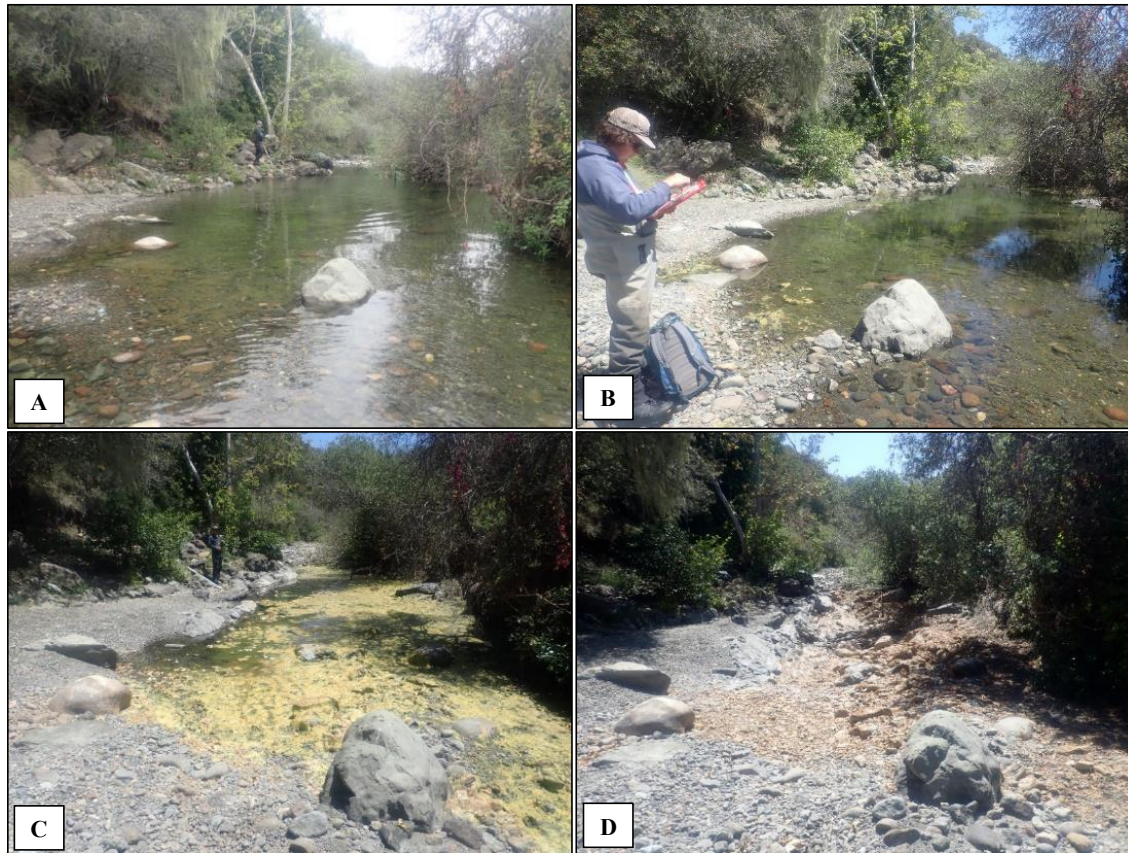
Figure 12. Looking upstream at pool where PT2 was installed on: (A) March 30 (0.86 cfs), (B) April 15 (0.14 cfs), (C) May 9 (0.05 cfs), and (D) June 13, 2022 (0.0 cfs).

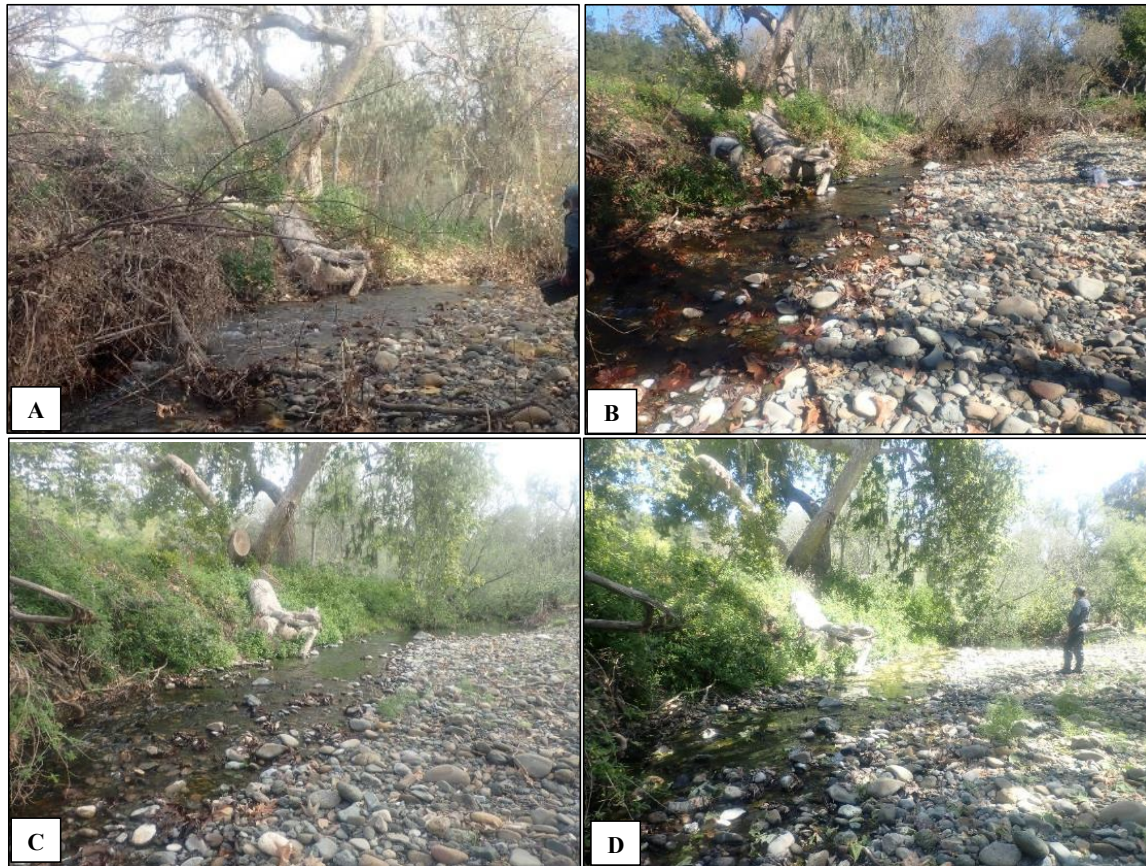
**Figure 18.** Riffle habitat at PPT1\* showing suitable BMI habitat and juvenile steelhead passage at 4.10 cfs (A) and 1.56 cfs (B), BMI habitat but no juvenile steelhead passage at 0.86 cfs (C), and no BMI habitat or juvenile steelhead passage at 0.11 cfs (D).

Observations from the riffle assessments were evaluated to understand what flows supported productive BMI habitat and passage conditions for juvenile steelhead within the Study Reach. Suitable conditions to support BMI production in riffles were observed at all riffles assessed when flows ranged from 4.10 cfs to 0.86 cfs. At flows of 0.35 cfs, suitable conditions to support BMI production in riffles were observed at most riffles assessed while a few riffles no longer supported BMI production. When flows were below 0.35 cfs, no suitable habitat for BMI production was observed at any of the riffles assessed (Table 3). Photos showing riffle conditions over a range of flows are included in Figures 18–23.

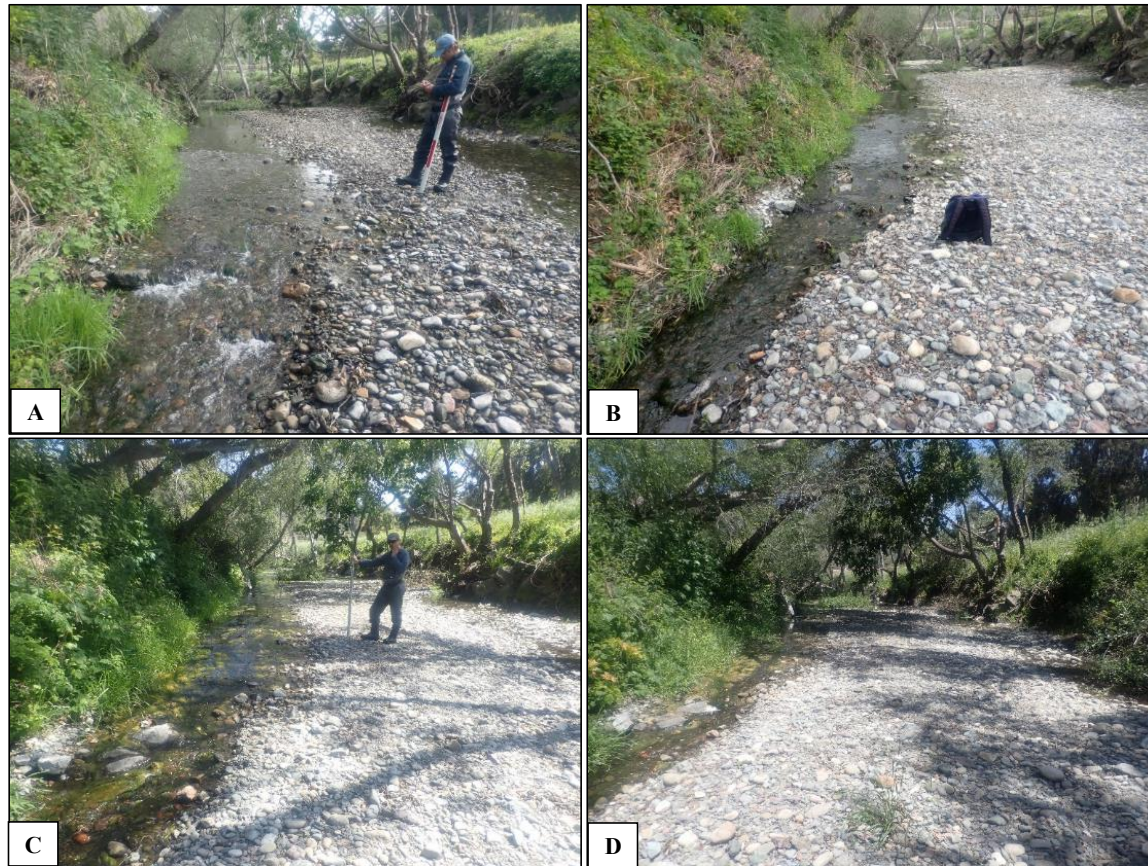
Figure 19. Riffle habitat at PPT1 showing suitable BMI habitat and juvenile steelhead passage at 0.86 cfs (A), BMI habitat but no juvenile steelhead passage at 0.35 cfs (B) and 0.11 cfs (C), and no BMI habitat or juvenile steelhead passage at 0.05 cfs (D).

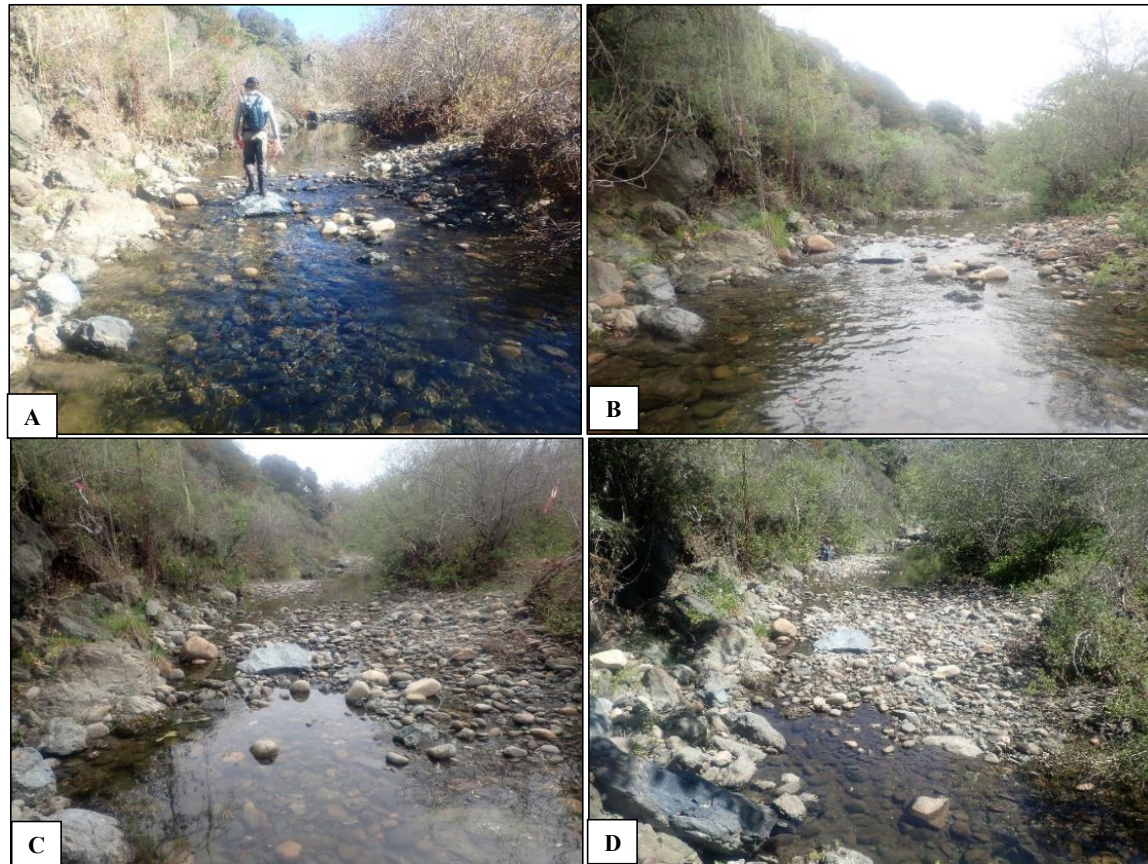
Figure 20. Riffle habitat at PPT2 showing suitable BMI habitat and juvenile steelhead passage at 1.56 cfs (A) and 0.86 cfs (B), BMI habitat but no juvenile steelhead passage at 0.35 cfs (C), and no BMI habitat or juvenile steelhead passage at 0.14 cfs (D).

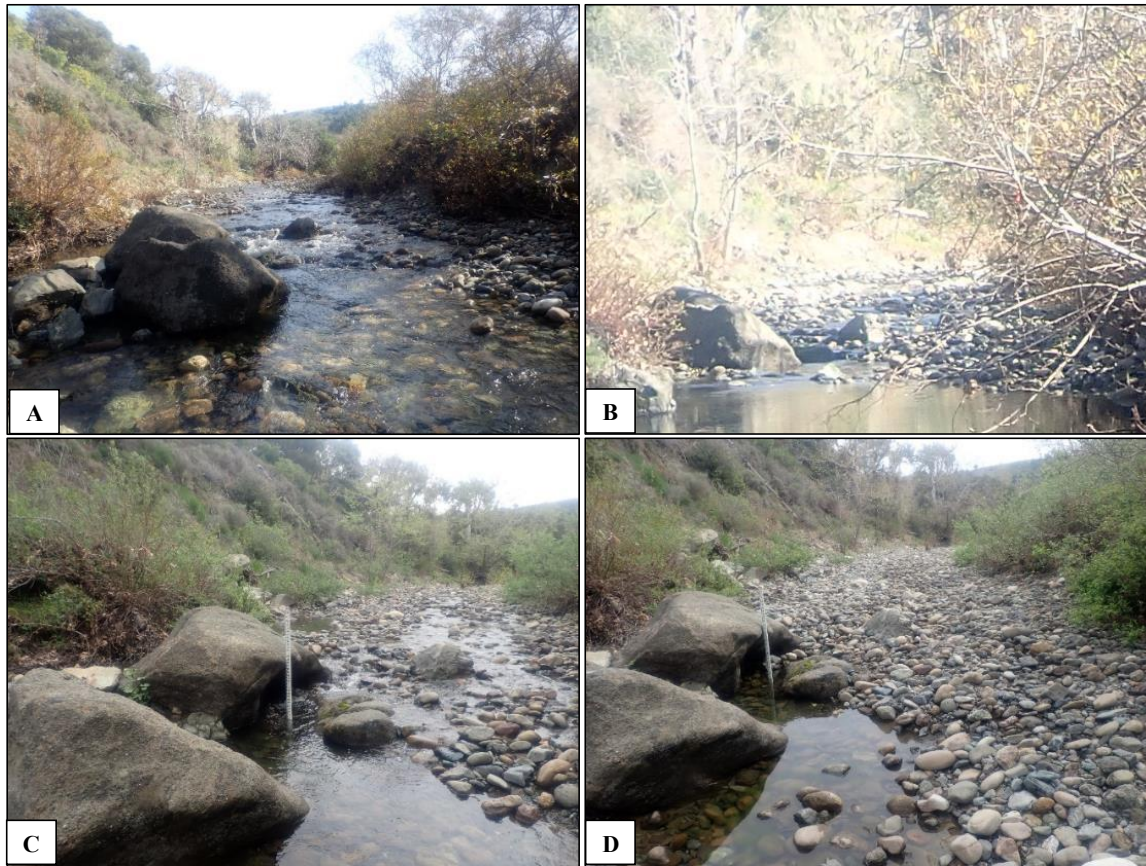
**Figure 21.** Riffle habitat at PPT6 showing suitable BMI habitat and juvenile steelhead passage at 4.10 cfs (A), BMI habitat but no juvenile steelhead passage at 1.56 cfs (B) and 0.86 cfs (C), and no surface flow when flows measured downstream were 0.35 cfs of less (D).

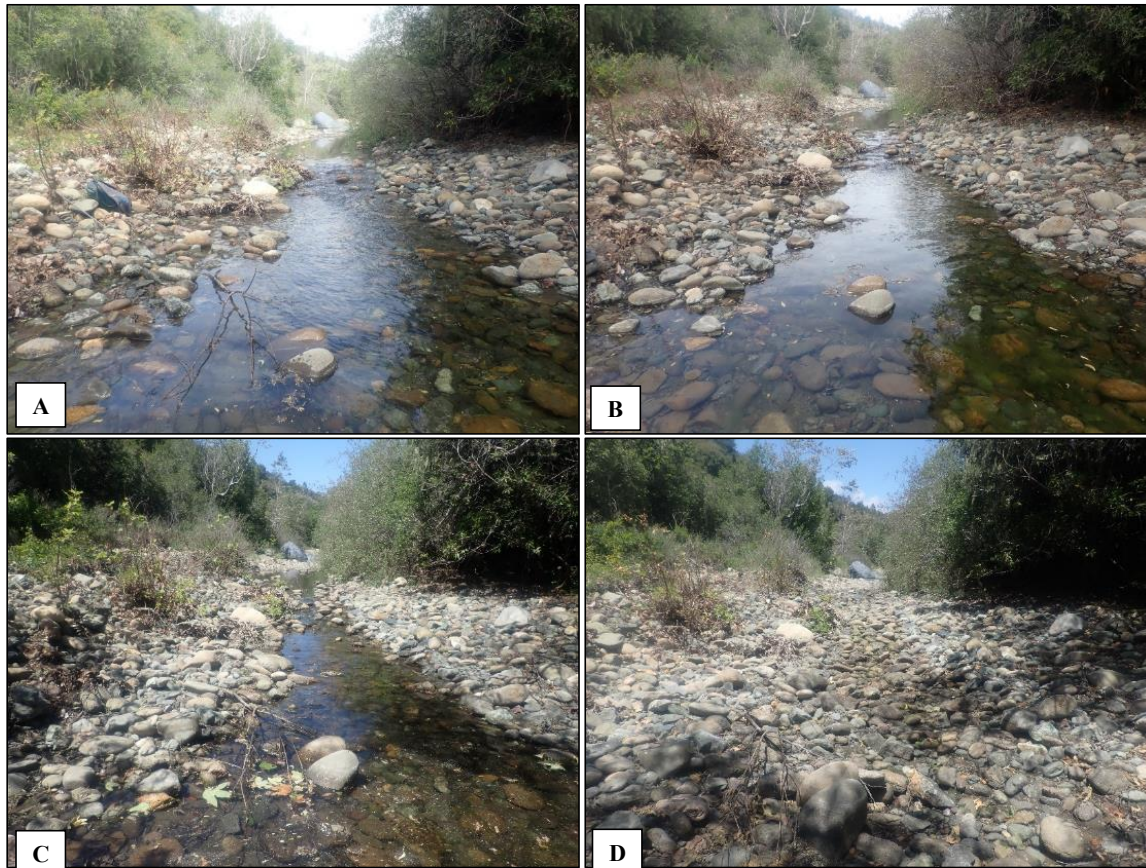
Figure 23. Riffle habitat at PPT9 showing suitable BMI habitat but no juvenile steelhead passage at 0.86 cfs (A), 0.35 cfs (B), and 0.14 cfs (C), and no surface flow when flows measured downstream were 0.05 (D).

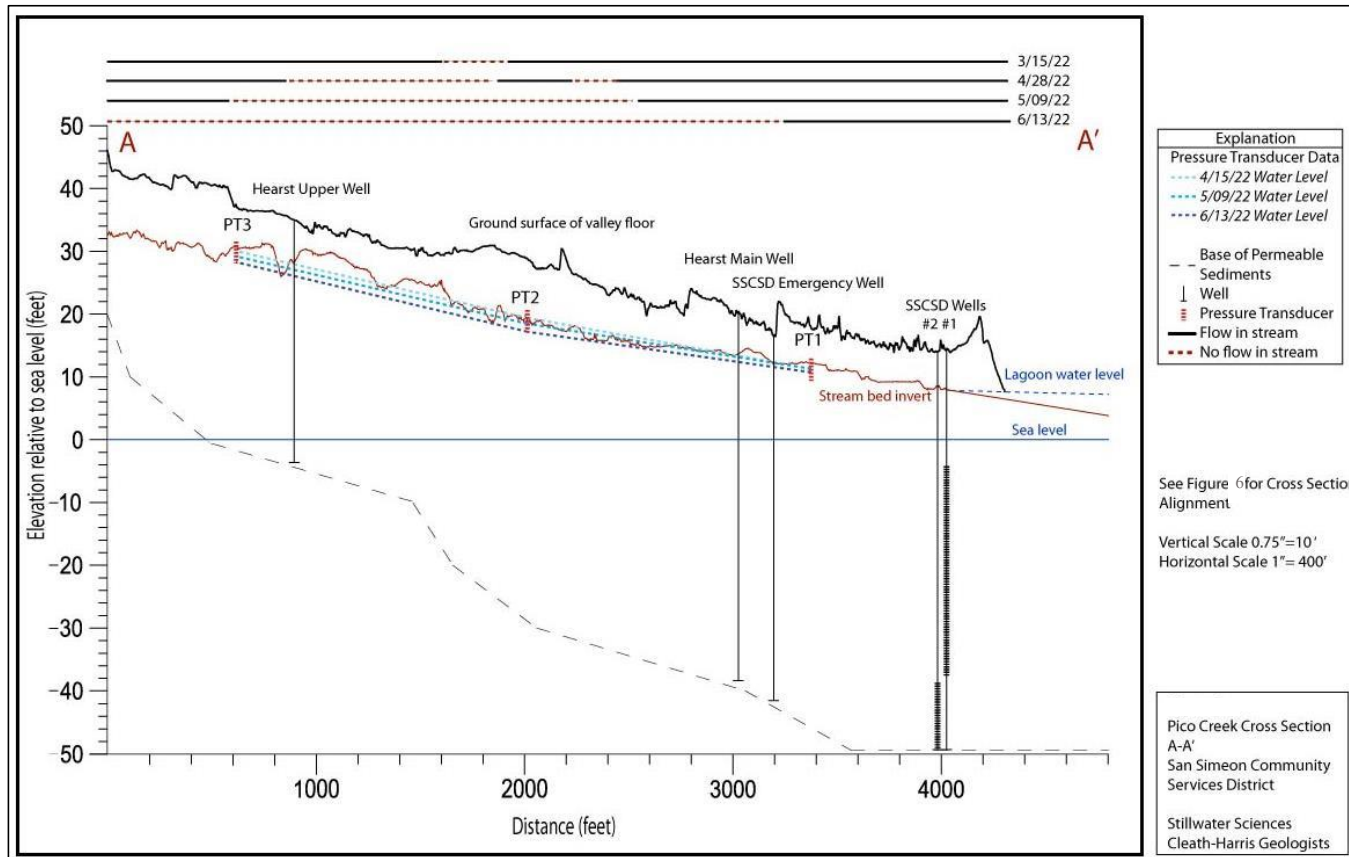
Figure 25. Pico Creek longitudinal elevation profile showing extent of intermittent stream flows in relation to groundwater wells along the Study Reach.

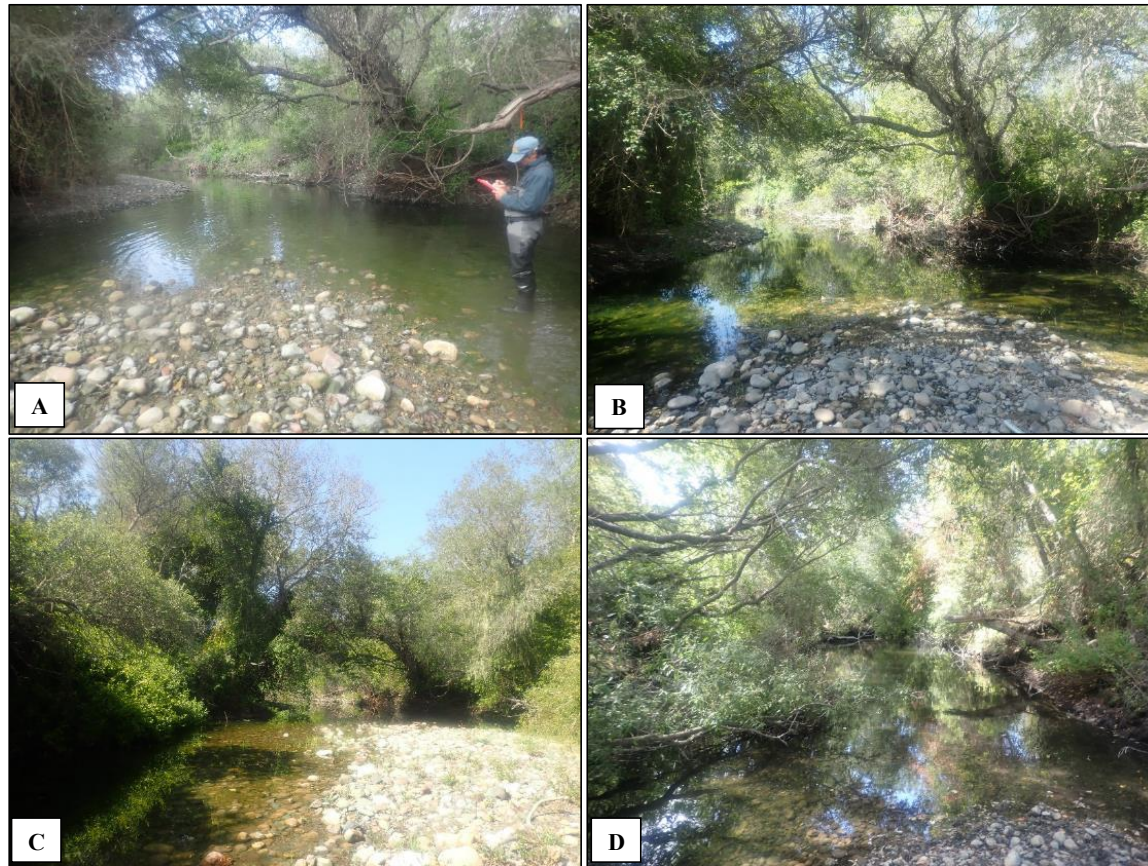
Figure 31. Upstream end of Pico Lagoon on March 30 (A), April 15 (B), April 28 (C), and July 12, 2022 (D).
